Service Bulletin

Title: **AEL18839 Camshaft Marking for O/IO-375 Series Engines**

SB No.: **13-1**

Issued: 03/15/2013

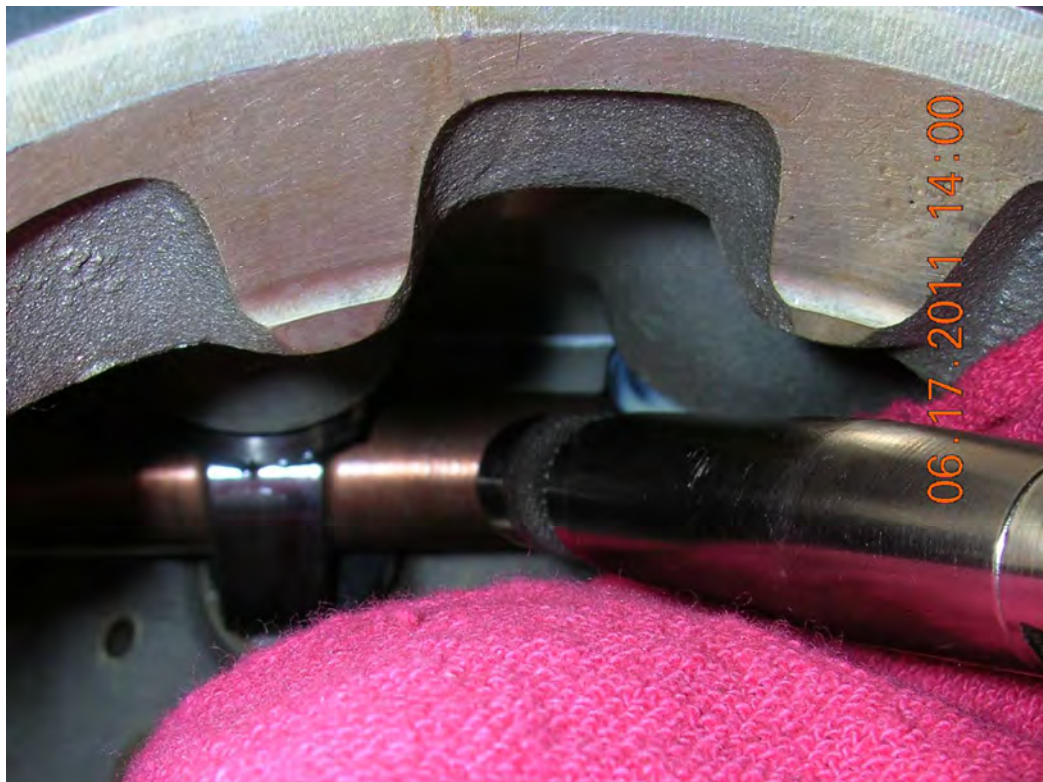
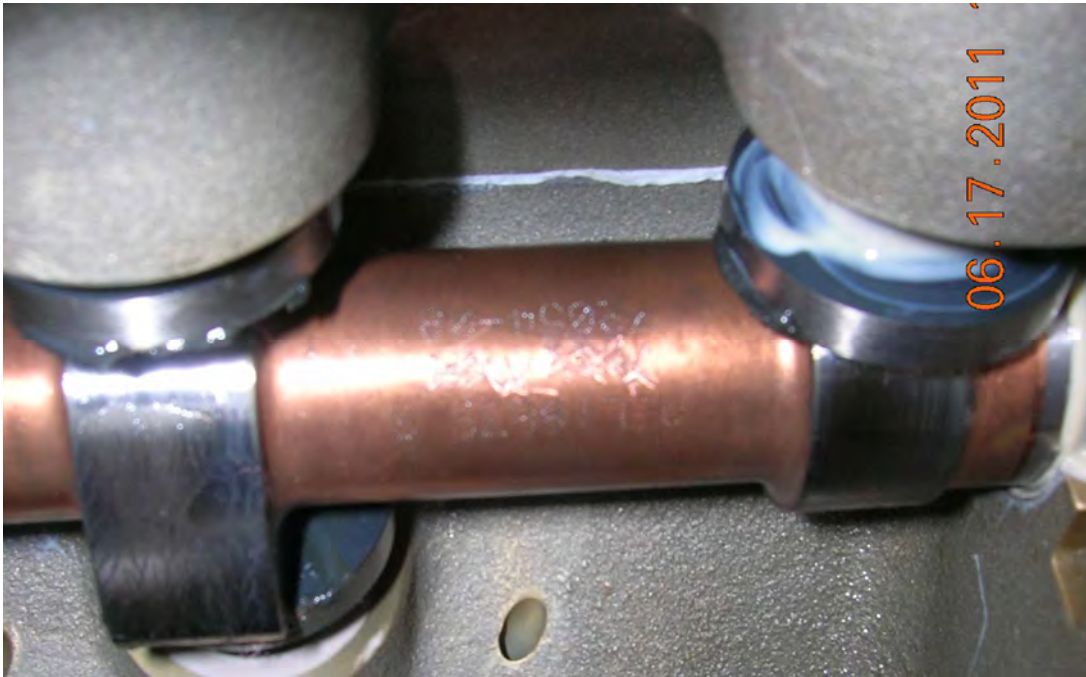
Engine Components International (ECi[®]) has determined that several AEL18839 camshafts for use on Experimental AeroSport Power O/IO-375 engines have been marked as “FAA-PMA”. There are 12 camshafts from this production lot that may exhibit this improper marking. This part is not approved for installation into a certified engine. AeroSport Power will notify customers with affected parts.

Place a rag under the camshaft to catch any metal debris. Using a hand vibropeen or equivalent tool, obliterate the “FAA-PMA” marking. See the photos below.

Visually inspect the marking to ensure the FAA-PMA is completely obliterated, photograph the obliterated marking with legible serial number and return to service.
